# Manhole Inspection Summary

Manhole # S59I\_\_007MH

Insp Date: **9/9/09 9:05 AM**

**Location** Address: **Portugal St.**

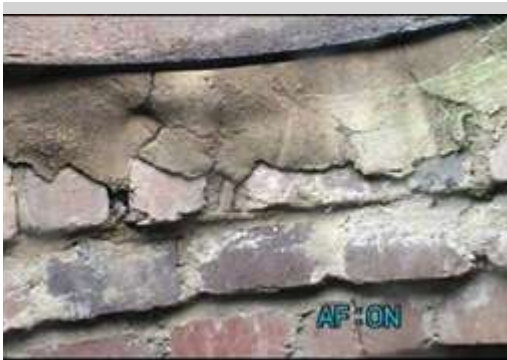
Miscellaneous

chimney repair

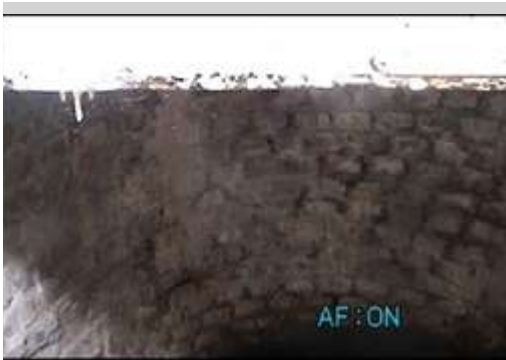
Miscellaneous

view of barrel facing 2:30 (under overhang)

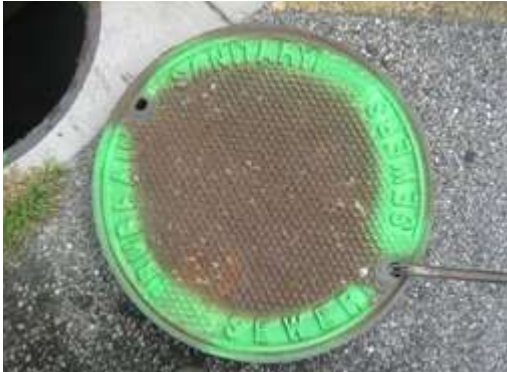
Miscellaneous

MH Lid

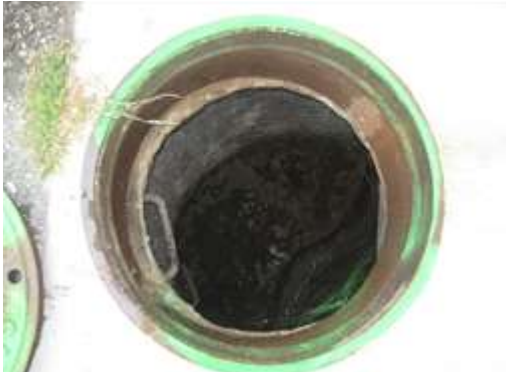
Defect 3

**Frame** Offset: **1** (in.) Condition: ☒ Sound ☐ Cracked ☐ Leaks

frame offset

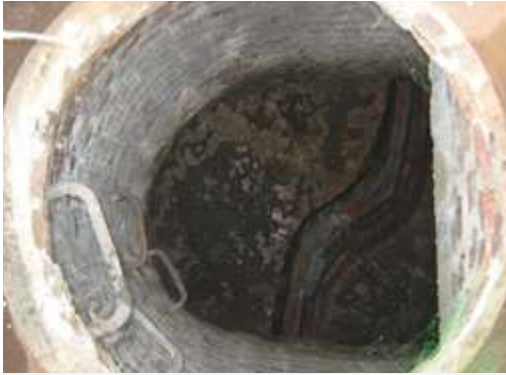
Defect 4

Condition: ☐ Sound ☐ Cracked ☐ Root Intrusion ☐ Deteriorated ☐ Leaks ☒ **Debris**

bench debris

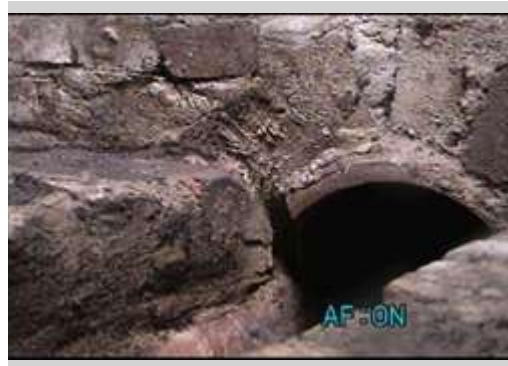
Defect 2

broken seal at the 6:00

Pipe Height: **8.4** (in.) Rod and Bar (Angled)  
Pipe Material: **Clay** ☐ Pipe Lined  
Invert Depth: **8.00** (ft.) Flow Characteristics: **None**  
Deposits: ☒ None ☐ Mud ☐ Sludge ☐ Debris ☐ Grease  
Silt Depth: **0** (in.) Deposits Extent:  
Infiltration: **None** Pipe Seal Cond: **Broken**

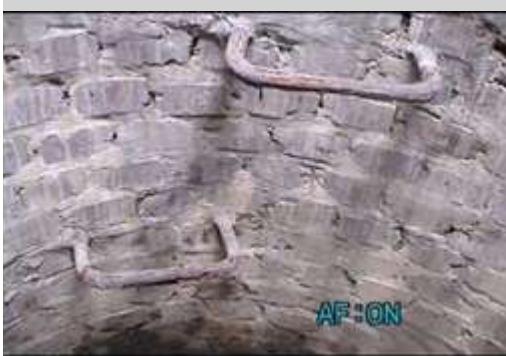
Defect 1

**Steps** Count: **4** Missing: **0** ☒ **Corroded**

corroded rungs
